A note on the ongoing reconstruction of Pratham Shree Mahavihar, Gustal Mahavihar and Vasucchashil Mahavihar at Guita, Patan (Lalitpur)

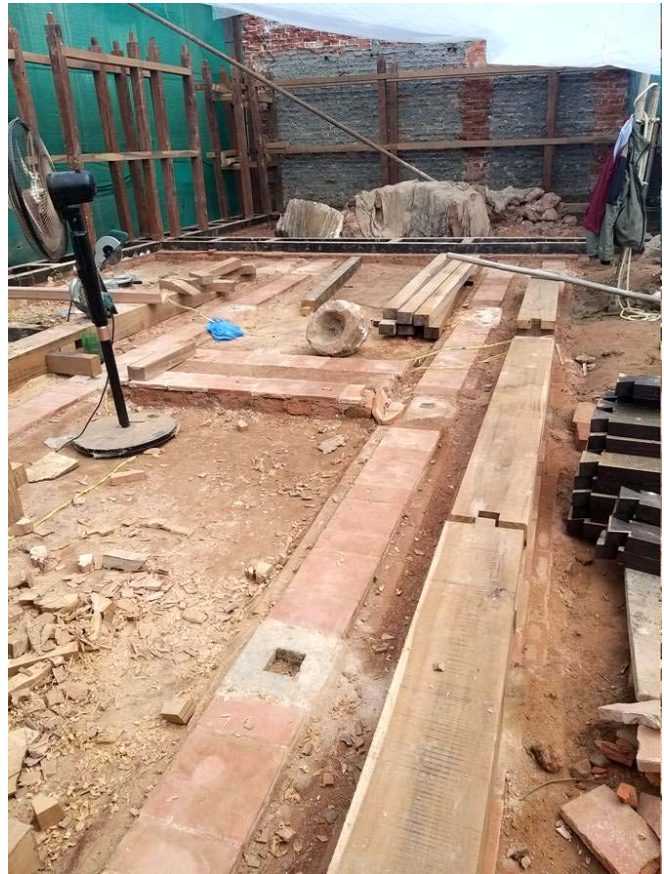
1. It was observed that in the ground floor of eastern wing of Pratham Shree Mahavihar, the already existing *ilōh* (saddle stones) were being lowered from their original level/position, only to bury them into the ground and top them with horizontal *lākāsī* (wooden base runner) to be finished at floor level. And the vertical posts were planned to be placed upon this *lākāsī* or the horizontal runner. But it might not take too long for a person even with a basic knowledge of traditional construction to realize that this approach is flawed. Laying horizontal *lākāsī* atop already existing *ilōh* (saddle stone) is not only inconsistent with the period detail but also is a grave error from the standpoint of building science and engineering. *Ilōh* are meant to bear vertical upright posts and whenever existing *ilōh* are discovered, it invariably means that these should have upright posts upon them.

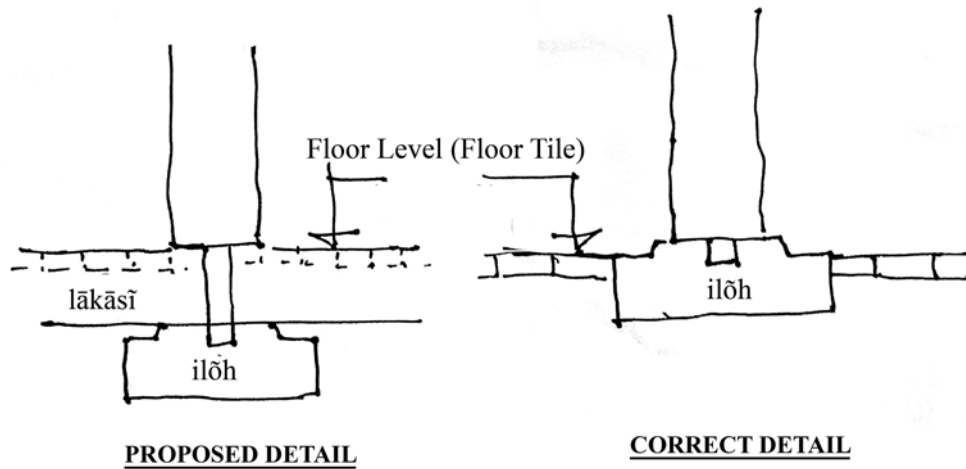
2. Connecting the *ilōhs* in the ground floor with horizontal ties of whatsoever nature is not a period detail and which is not practiced anywhere at all. Instances of these 'untied' *ilōhs* being displaced during the events of earthquake is hard to find.
3. An approximately 1.5" high sloping crown on the *ilōh*, which acts as the base of the upright post, slightly raises the base of the post up from the floor level so that any moisture on the floor would not find its way to the base of the post thus preventing the case of wet rot. The proposed detail in Pratham Shree Mahavihar with the base of the post right at the level of the floor, would let the moisture into the base easily, thus creating a

favorable environment for wet rot. The technical team involved might have been misinformed and misled about the floor tiles being water-proof (actually they are not). This might have led them about thinking of lining the base runner with floor tiles to prevent the case of wet rot. This is a totally wrong idea from the very outset.

4. In our tradition, we do have the practice of using *lākāsī* (base runner) to hold the upright posts, but in a different context. These *lākāsī* (base runners) are normally placed at plinth level in *falcā* of *pāti* or *sattals* - where they are placed upon vertical mirror stones so that they will have no contact with the soil below and provisions are made for them to ventilate. Besides the adjacent flooring is dry lined using timber planks (which is used for sitting/resting). The case here is entirely different. The proposed detail with *lākāsī* finished at floor level and with adjacent floor tile finish would not save it too long from wet rot. Coating with black japan (bitumen based paint) or other makeshift methods are only temporary or short term measures.

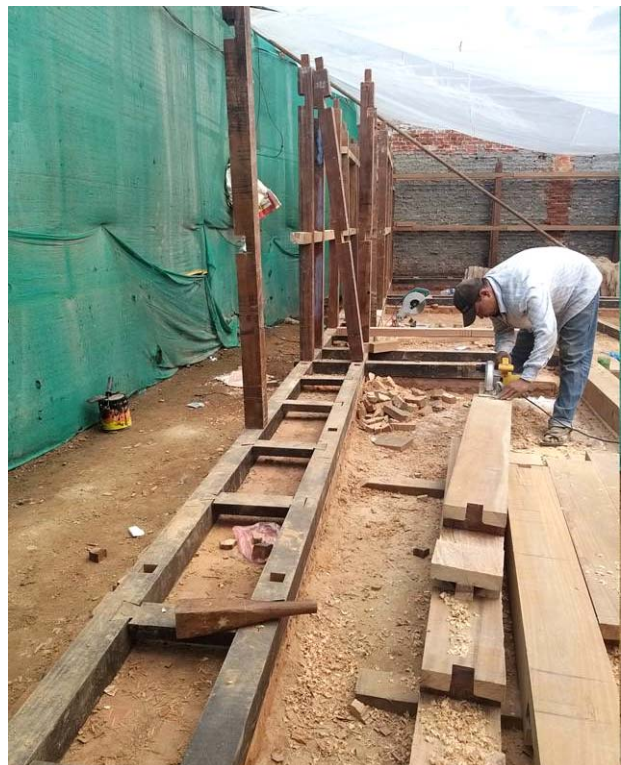
1. Placing vertical *du thāms* (inner posts for walls) and intermediate horizontal ties on the outer and inner surface of the masonry wall is found to be widely practiced during Malla period.
2. The vertical *du thāms* and horizontal ties are seen here to be cross-lapped using half lap joint - which is a flawed detail. Normally the intervention to the vertical posts is kept to a minimum as far as possible. The slots for half lap at intermediate levels of the vertical *du thāms* will only reduce the structural integrity of the post. The horizontal ties are normally attached to the vertical *du thāms* by inserting tenon at the ends of ties into a small mortise hole cut into the vertical *du thāms*. Besides, the thickness of the horizontal ties is also kept equal to the thickness of one course of brick, which will help in adjusting the ties with the brick course

easily. Here the thickness of the horizontal ties appears to be off-sized.

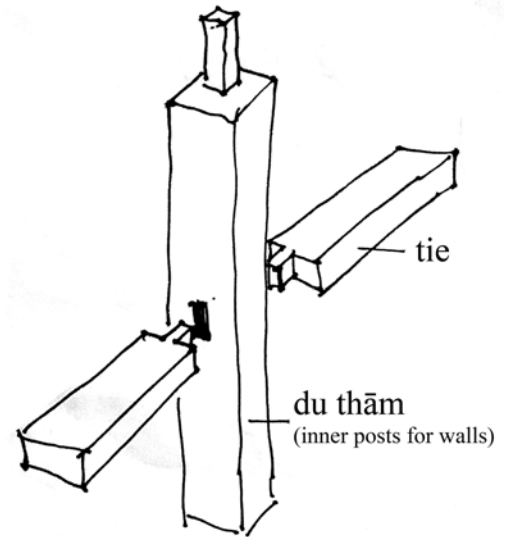
3. There seems to be an attempt to place a layer of horizontal tie at the floor level - which will not survive too long from wet rot.

4. It is also found that the proposed frame of *du thāms* and horizontal ties has been unnecessarily made too dense by placing them at close spacing. Our traditional structure invariably has the load bearing nature where any sensitive use of wooden ties will only enhance the structural performance of the brickwork. In this case, the dense network of frame is making the structure to lose its inherent load bearing nature and the structure is inclined more towards taking up the nature of frame structure. This again is a radical change to the very essence of heritage structure. The decision makers have failed to realize at what point the structure starts losing its load bearing nature and starts embracing the nature of frame structure.

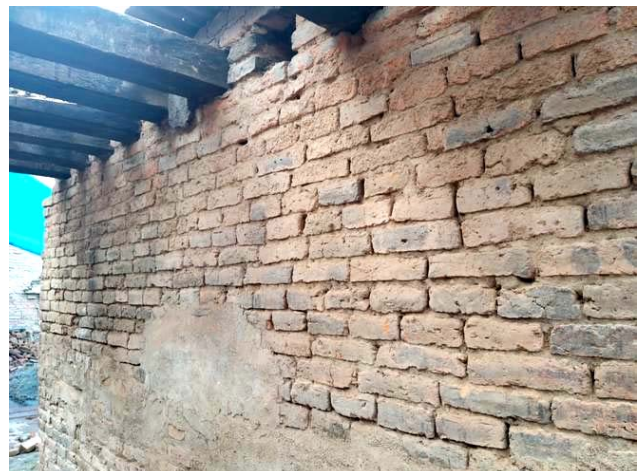
1. The brick bonding pattern in masonry wall with two courses in header and two courses in stretcher is an old one. It might be in use in Lichchhavi and till Pre Malla period. Similar pattern of brick bonding can be seen in the recently opened wall behind the Kwapa Dyo of Gustal Mahavihar, - which itself proves the antiquity of the structure. It shows that, unless the walls are rebuilt or changed over the time, the whole complex of this mahavihar should have the same

pattern of brick bonding. However, it is seen that in the reconstruction of foundation walls and walls of some sections, this pattern has not been followed. It might seem a trivial detail, but for the character of the structure belonging to Lichchhavi period, this is a significant detail.
